CONSERVABILITY OF YORAN/DIDYMA TRADITIONAL RURAL-ARCHAEOLOGICAL SETTLEMENT: A HISTORICAL REVIEW ON THE CHANGE IN PERCEPTIONS OF CULTURAL HERITAGE VALUES

Keywords: Rural architectural heritage, archaeological heritage, cultural heritage values, conservation, Yoran (Eski Hisar)/Didyma.

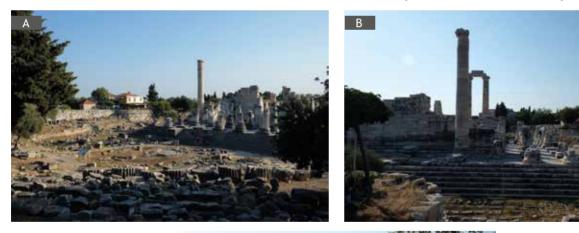
Figure 2. Archaeological remains of Didyma (a), (b) The Temple of Apollo (c) The Processional Way (Photos taken by Harman Aslan, 2016). / Didyma'nın Arkeolojik Kalıntıları (a), (b) Apollon Tapınağı (c) Kutsal Yol (Fotoğraflar, 2016 yılında Harman Aslan tarafından çekilmiştir).

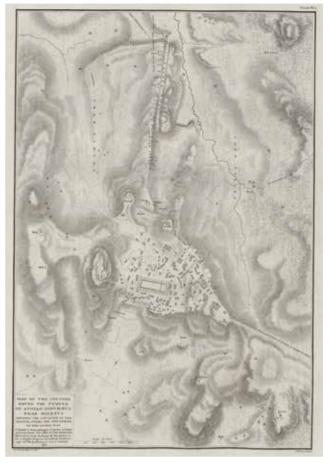
Figure 3. Rural settlement around the Temple of Apollo at the beginning of the 19th century (Gell, 182, Plate I). / 19. yüzyılın başlarında Apollon Tapınağı çevresindeki kırsal yerleşim (Gell, 182, Levha I).

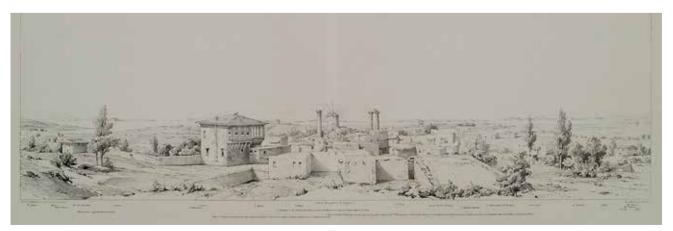
Figure 4. In the 1826 Laborde engraving, a panoramic view of the Temple of Apollo and the surrounding countryside is shown (De Laborde and De Laborde 1838, PL. XLVII, p.95). / 1826 Laborde gravüründe, Apollon Tapınağı ve çevresindeki kırsal alanın panoramik bir görünümü gösterilmektedir (De Laborde ve De Laborde 1838, PL. XLVII, s.95).

Alexander de Laborde, who visited Anatolia in 1826, published "Voyage de l'Asie Mineure" in 1838, which featured an engraving titled "Apollo Temple Ruins" (De Laborde & De Laborde, 1838, PL. XLVII, p.95). In this engraving, the village houses surrounding the ruins of the Temple of Apollo are also depicted. The majority of these houses are single-story masonry structures with flat roofs. On their facades, there are a few small openings. A two-story mansion in the engraving, where masonry and wooden systems are combined, stands out among the modest village houses. This building must have a bay on the upper floor and numerous large windows. The building is covered with a hipped roof. In addition, the engraving shows the windmill on the Temple of Apollo, which was demolished during later archaeological studies (Figure 4).

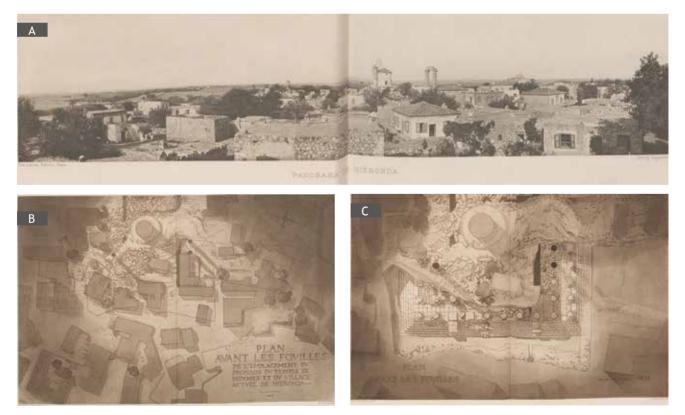
Figure 5. (a) Panoramic photograph of Yoran at the end of the 19th century (b) Houses and windmill in the area of the Temple of Apollo before the 1895/96 excavations (c) The Temple of Apollo and its near surrounding after the 1895/96 excavations (Haussoullier & Pontremoli, 1904). / (a) 19. yüzyılın sonunda Yoran'ın panoramik fotoğrafi (b) 1895/96 kazılarından önce Apollon Tapınağı bölgesindeki evler ve yel değirmeni (c) 1895/96 kazılarından sonra Apollon Tapınağı ve yakın çevresi (Haussoullier ve Pontremoli, 1904).

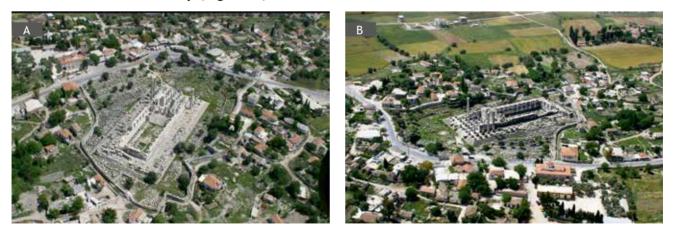
Figure 7. (a), (b) General view of Yoran today (Source: Didim Municipality Archive). / (a), (b) Yoran'ın bugünkü genel görünümü (Kaynak: Didim Belediyesi Arşivi).

The distribution of Yoran's traditional rural buildings today complies with the topography. The Temple of Apollo is located in the middle of the community, which is surrounded by typical rural architecture. The building density gradually decreases until it comes to an end with the placement of some agricultural regions. The rural

settlement has olive groves in the north, agricultural lands in the northeast and south, a cemetery in the east and new settlements in the east and west (Figure 7).

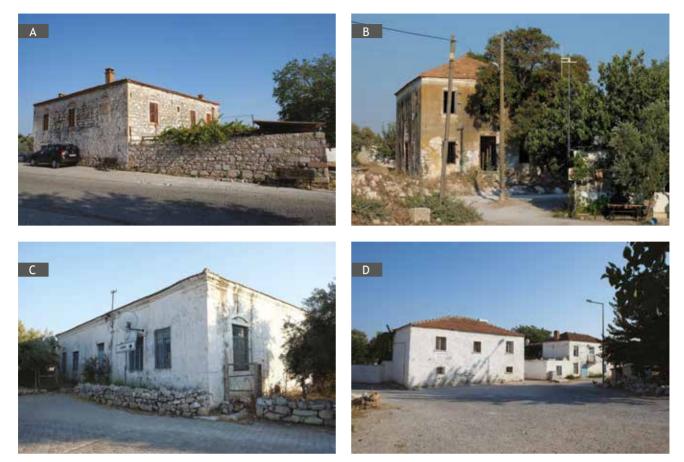
Figure 8. (a), (b), (c), (d) Traditional rural buildings in Yoran (Photos taken by Harman Aslan, 2016). / (a), (b), (c), (d) Yoran'da geleneksel kırsal yapılar (Fotoğraflar, 2016 yılında Harman Aslan tarafından çekilmiştir).

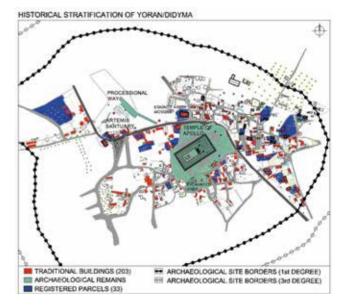
Figure 9. Archaeological and traditional rural fabric layers in Yoran/Didyma Sanctuary (Updated by authors base on Omay Polat et al. (2013, p.509)). / Yoran/Didyma Kutsal Alanı'ndaki arkeolojik ve geleneksel kırsal doku katmanları ((Omay Polat vd., (2013, s. 509) esas alınarak yazarlar tarafından güncellenmiştir).

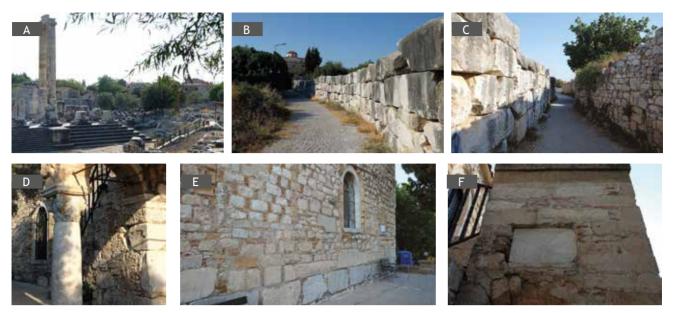
Figure 10. (a), (b), (c) Coexistence of archaeological remains and traditional rural architecture in Yoran (d), (e), (f) Spolia used in the traditional rural fabric in Yoran (Photos taken by Harman Aslan, 2016). / (a), (b), (c) Yoran'da arkeolojik kalıntılar ile geleneksel kırsal mimari birlikteliği (d), (e), (f) Yoran'da geleneksel kırsal dokuda kullanılan devşirme malzemeler (Fotoğraflar, 2016 yılında Harman Aslan tarafından çekilmiştir).

Later societies continued to use the buildings and remains of previous civilizations in Yoran. The Hellenistic Temple of Apollo, whose ruins have survived to the present day, was converted into a castle in the 3rd century AD and a church in the 5th century AD. In the 19th century, there were village houses and a windmill where the temple was located. Today, the Temple of Apollo, as a part of the archaeological site, is the subject of scientific and educational studies and also welcomes visitors. The church, built in 1830, was converted into a mosque and is still in use. The chapel, which was in a state of ruin until recently, was repaired and has today regained its original function. This building serves both the foreign population who have settled in the Didim center and its surroundings and the tourists. The Muslim community who immigrated from Greece and Bulgaria during the exchange still resides in Yoran's built environment, a Greek village until the population exchange in 1924. The use of traditional rural architecture continued in this way. The built environment's continued use from the past to the present increases the settlement's continuity value.

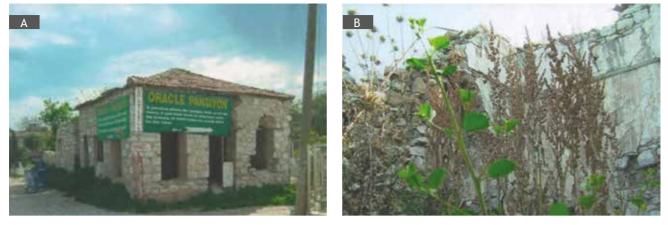
Figure 13. (a)The building with parcel number 1852, which was decided to be demolished (b) Remains of building with parcel number 1915 (Source: Didim Municipality Archive). / Yıkılmasına karar verilen 1852 parsel numaralı yapı (b) 1915 parsel numaralı yapı kalıntısı (Kaynak: Didim Belediyesi Arşivi).

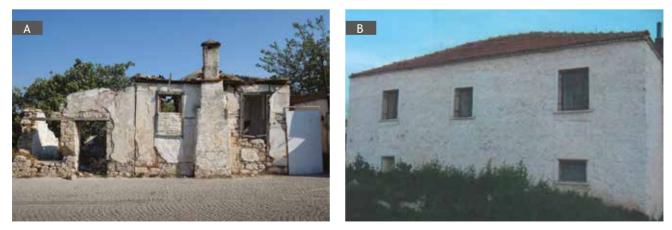
Figure 14. (a) Building with parcel no 1742, which is not worthy of registration as a cultural property to be protected (b) Building with parcel number 1797 (Source: Didim Municipality Archive). / (a) Korunması gerekli kültür varlığı olarak tescili uygun görülmeyen 1742 parsel numaralı yapı (b) 1797 parsel numaralı yapı (Kaynak: Didim Belediyesi Arşivi).

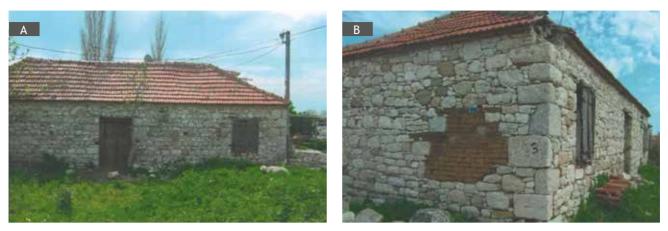
Figure 15. (a), (b) The building with parcel number 1843, which is registered as a cultural property to be preserved (Source: Didim Municipality Archive). / (a), (b) Korunması gerekli kültür varlığı olarak tescillenen 1843 parsel numaralı yapı (Kaynak: Didim Belediyesi Arşivi).
